RE: Egloff House

STUDY FOR THE PRESERVATION AND MOVE OF THE EGLOFF HOUSE

FIELD OBSERVATION REPORT

PROJECT: OBSERVATION OF HOUSE AT 655 7TH STREET NE, MASON CITY, IOWA

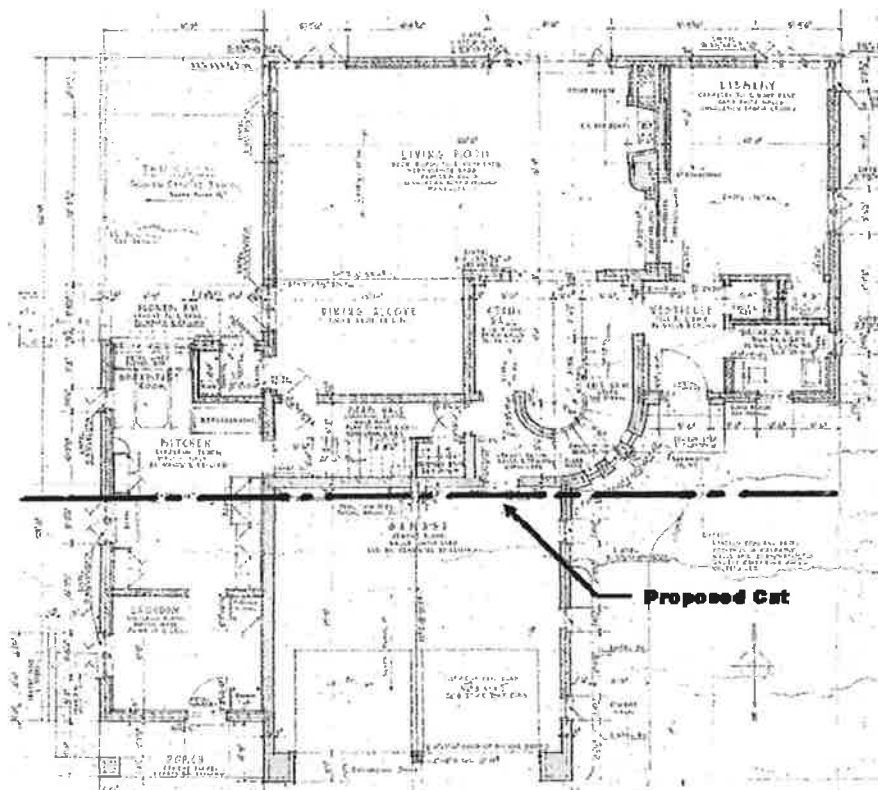
The dashed line indicates a proposed cut through building for moving.

First, it is preferred that the entire structure be moved and relocated. The building will need to be split into two sections for clearances to travel down the city streets to its new location. It is highly recommended that both sections be moved and tied back together seamlessly at a new site. There is a later framed addition on the back corner of the house that could be left off if necessary without any ramifications for later qualifying for the National Register or subsequent preservation grant funding.

Second, if the building is moved in two sections, it should be seamed together again with like materials i.e. stucco, rubber membrane roofing etc. Matching the exterior stucco finish will be a challenge and take special skills to blend in with the existing stucco. The interior should also be patched with similar materials such as the plaster, wood flooring and trim and painted to match the existing.

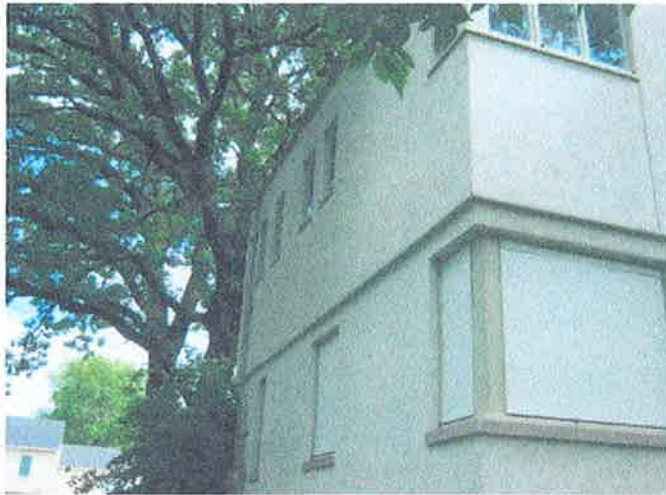
CRACKING AT CORNER

2. The Sheffield floor appeared to be in good condition.
3. There was observed signs of past water damage due to a flood.
4. There was observed cracking along the rear right corner of the house.

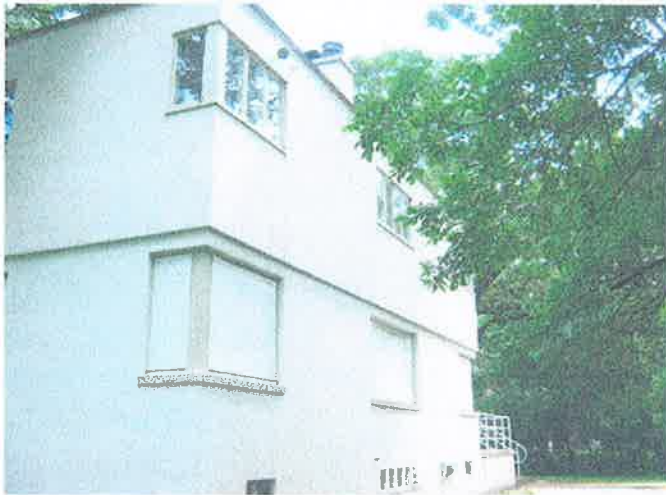
CRACKING AT CORNER

5. There was observed cracking along the rear left of the house.
6. There was observed cracking along the rear foundation of the house.
7. There was observed some cracking at the windows along the rear of the house.

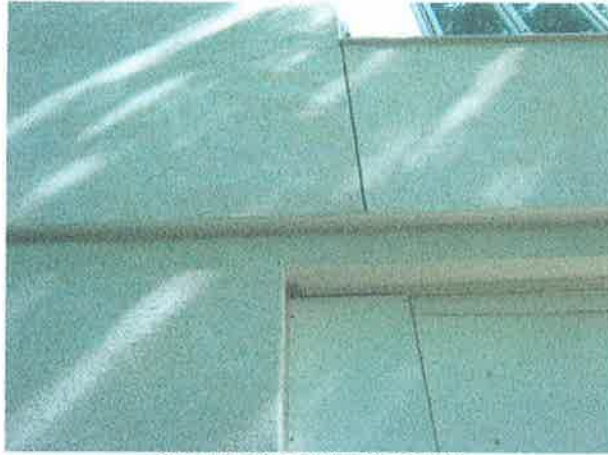
CRACKING AT THE CORNER

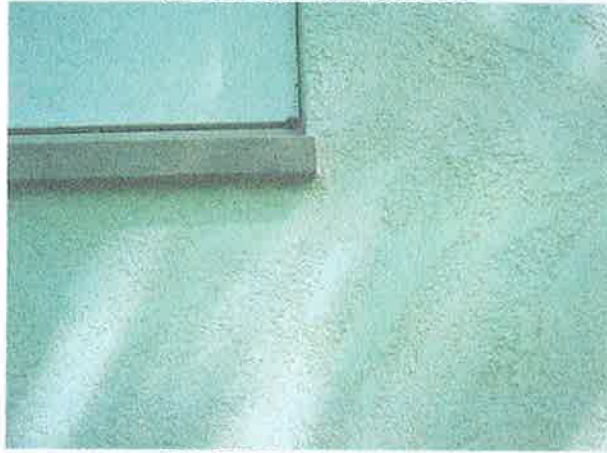
CRACKING AT REAR WALL

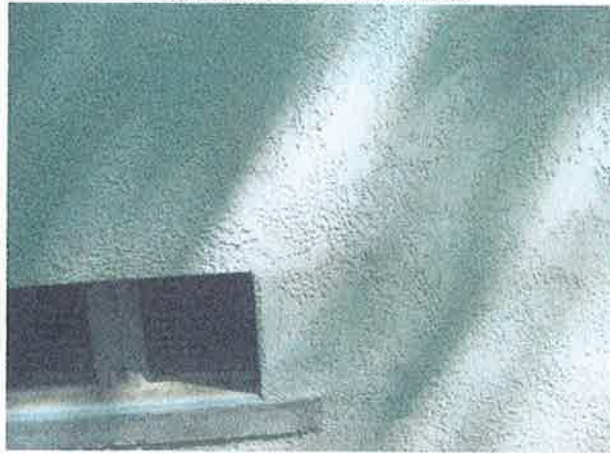
CRACK AT REAR WALL
